Broken STE-M1/FVS Is a Dead End

Store Your Gear Here!

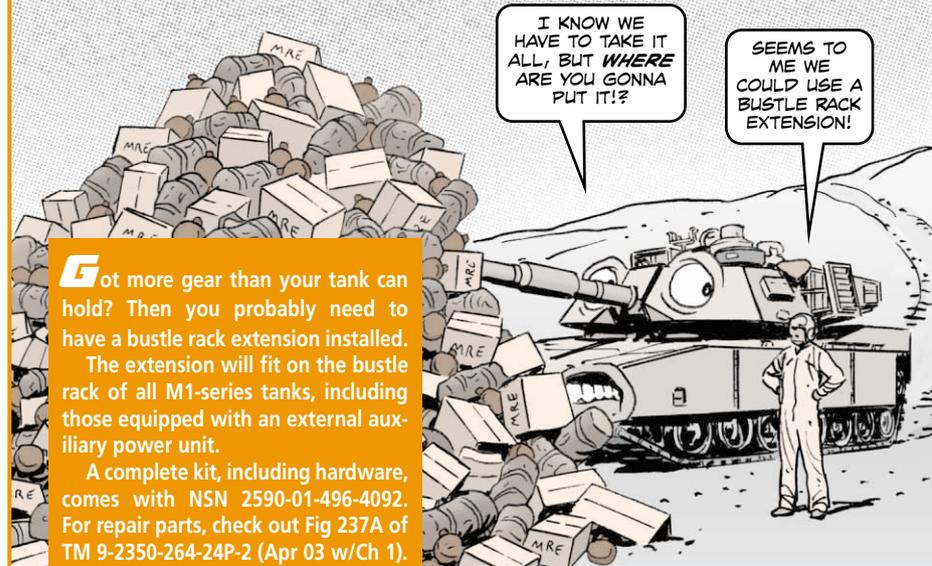
Got more gear than your tank can hold? Then you probably need to have a bustle rack extension installed.

The extension will fit on the bustle rack of all M1-series tanks, including those equipped with an external auxiliary power unit.

A complete kit, including hardware, comes with NSN 2590-01-496-4092. For repair parts, check out Fig 237A of TM 9-2350-264-24P-2 (Apr 03 w/Ch 1).
