LOOK FOR SAGGING TROUGHS

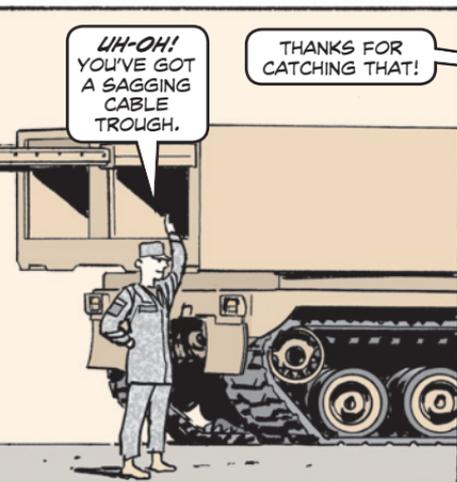
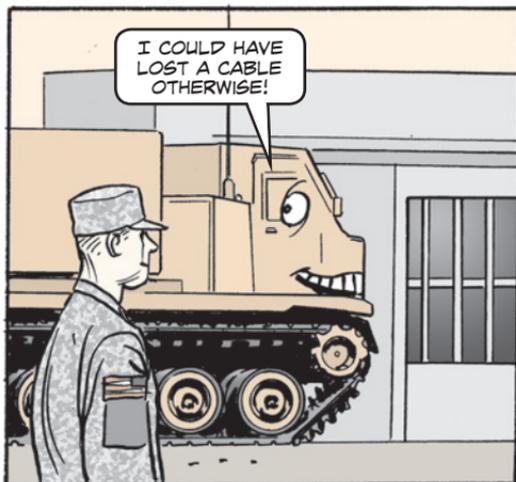
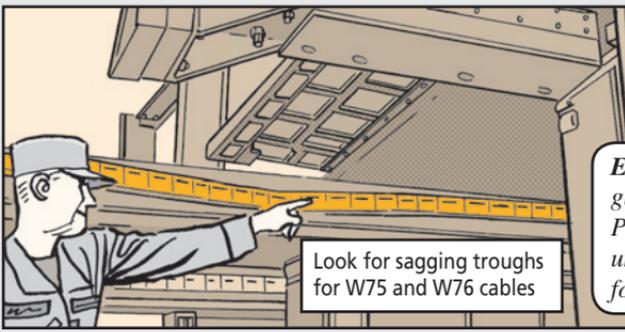
The MLRS W75 and W76 cables run in troughs along each side of the inside top of the launcher bays. The troughs are held in place by clamps that sometimes work loose.

Then the W75 and W76 cables work loose and get wound in the worm gear of the boom extension actuator. That can destroy the cable, which is expensive and difficult to replace.

Crews can prevent that by just looking at the troughs for the W75 and W76 when they do PMCS. If you see any sagging, let your repairman know. He can check for:

- loose clamps that secure the cable to the tray and hoist carriage
- a loose beam that supports the rollers the cables run through
- loose hardware that secures the tray and cable to the hoist carriage
- frozen rollers that the cable runs through
- too many alligator clips

Editor's note: Just a glance skyward during PMCS can save your unit big bucks. Look for sagging troughs!
