# HEATER MELTDOWN

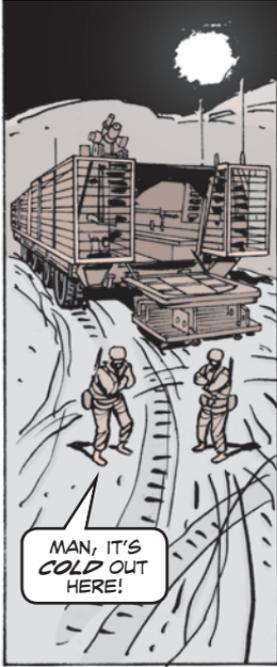
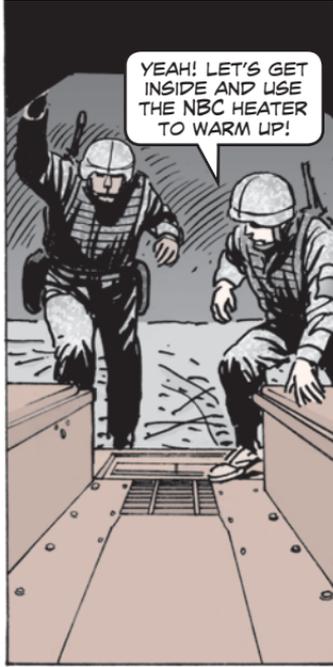
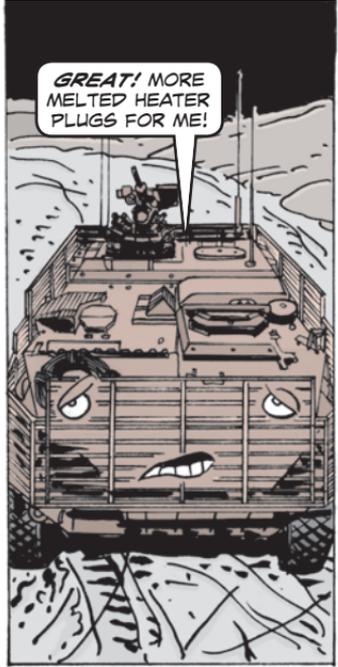
Soldiers being transported in Strykers often use the NBC/M3 heater as a way to warm themselves when temperatures drop. They stick the hose inside their uniforms and turn up the heater full blast.

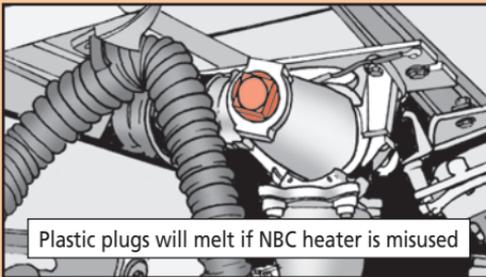
Unfortunately, the heater wasn't designed for that. The unit overheats and the two plastic plugs at both ends of the heater melt.

Replacement plugs aren't available, so a new heater, NSN 4240-00-807-6856, has to be ordered to repair the heater. That'll set your unit back more than \$200.

Check out WP 0070 00-1 in TM 9-2320-311-10-1 for proper operation of the NBC/M3 heater.
