AVOID A COVER CALAMITY

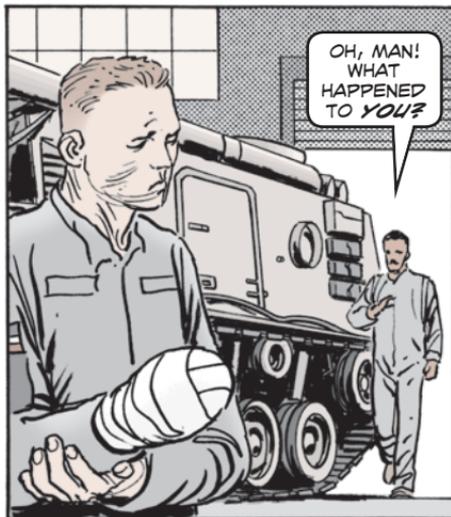
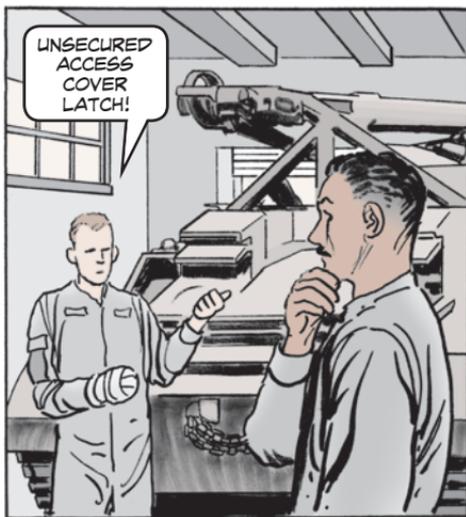
Crewmen, be **very** careful when opening and securing the transmission oil filler access cover on your M88A1.

Because the boom is often in the way, the latch that holds the cover up may not catch properly. The cover is very heavy, so you don't want to be in the way if it falls suddenly.

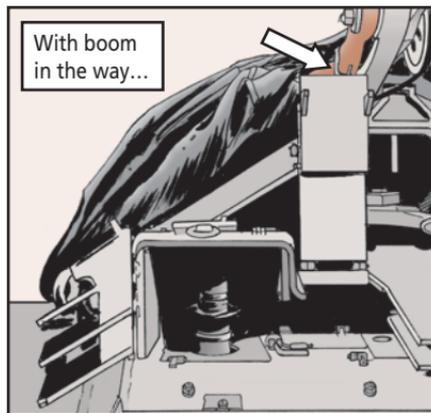
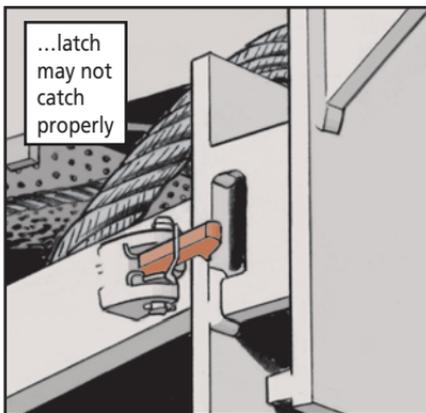
Some mechanics have had their fingers broken when an unsecured cover came crashing down.

So, when raising the cover, make sure the latch catches properly. If it won't because of the boom, either raise the boom slightly, or get someone to hold the cover up.
