# DETECTING DEFECTIVE BUFFERS

Some defective M296 machine gun recoil buffer assemblies have gotten into the supply system and could be in use on your OH-58D. The buffer rivets securing the depressors onto the oil buffer body were installed wrong. The rivet heads can back out and interfere with the accelerator.

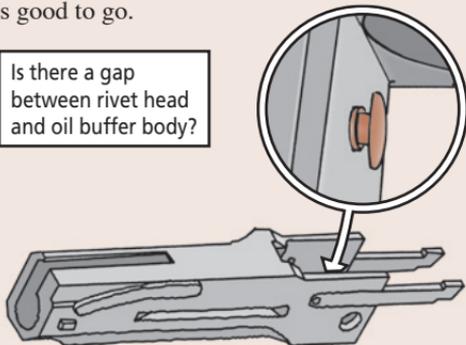
If it does have 28210, see if there's a gap between the rivet heads and the inside of the oil buffer body. If there's no gap, the buffer assembly is OK.

Is there a gap between rivet head and oil buffer body?

Buffer assemblies that fail the inspection should be marked defective condition code L and reported on an SF-368, *Quality Deficiency Report*. You can do this at <https://aeprs.ria.army.mil> or by emailing [QAWQDRS@ria.army.mil](mailto:QAWQDRS@ria.army.mil). You can also fax the form to DSN 793-6653/(309) 782-6653. As soon as the SF-368 is received, your unit will receive credit for the buffer assembly.
