Open Vents Clog A/C

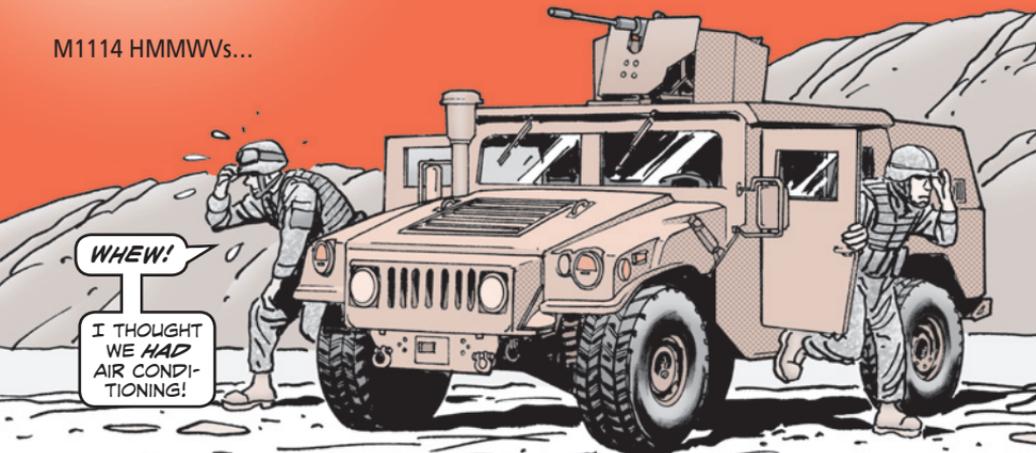
Operators, **don't** leave the A/C system's air vent open in your M1114 HMMWVs! When it is open—knob in the pushed-in position—the A/C evaporator coils get clogged with dirt, *hindering your A/C's performance*. You may open the vent long enough to de-fog windows, but then **close the air vent**. When the air vent is closed—knob in the pulled-out position—air re-circulates in the cab, reducing clogging.

Mechanics, de-clog the coils by thoroughly rinsing them with low-pressure potable water while using a fin comb, PN 55719, to straighten and clean condenser and evaporator fins. That fin comb comes with the refrigeration equipment tool kit, NSN 5180-00-596-1474.

Clogged coils? Thoroughly rinse with low-pressure potable water
