Stryker...

AVOID THE SHACKLE CRUNCH

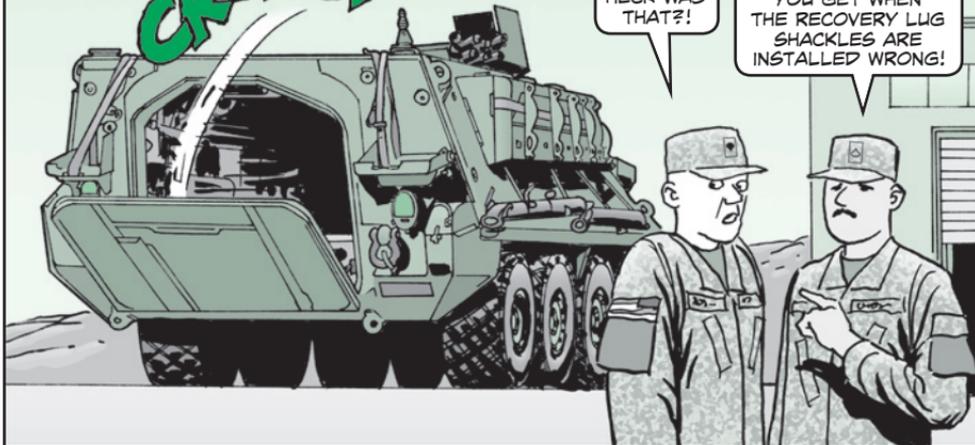
If the shackles are installed with the retaining nut and cotter pin facing inside, the ramp could hit them as it's lowered.

To prevent the damage—and the noise—make sure the retaining nut and cotter pin are installed facing away from the ramp. Then double-check the shackles as part of your before-operation PMCS.
