TRANSMISSION AND FREEWHEEL OIL FILTERS

Mechanics, inspect your Kiowa Warrior's transmission and freewheel oil system filter, NSN 4730-01-214-1465, to make sure you have the right configuration.

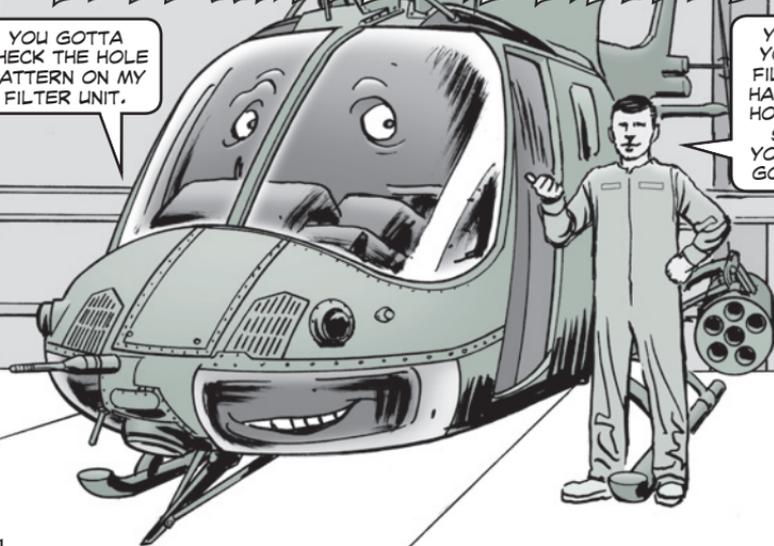
YOU GOTTA
CHECK THE HOLE
PATTERN ON MY
FILTER UNIT.

YEP!
YOUR
FILTER
HAS 65
HOLES,
SO
YOU'RE
GOOD!

Examine the filter unit screen hole pattern. If it doesn't have at least 65 holes, replace it with the correct filter.

Minimum
of 65 holes
is required

Fewer than 65
holes? Remove
from service

The filter unit will not affect the normal operation of your bird, but the AMCOM headshed wants the incorrect filters replaced at the unit's earliest convenience. They put out a maintenance information message (MIM) OH-58D-MIM-2006-011 as a heads-up to units that the part was incorrectly manufactured.

To receive the correct filter, order it through normal supply channels.

If the oil filter unit on your bird has a minimum of 65 holes, then your aircraft is good to go. You can reference the part in EM-0256, IETM 1-1520-248-23P, Fig 89, Item 103.
