GOT THE RIGHT GAUGE?

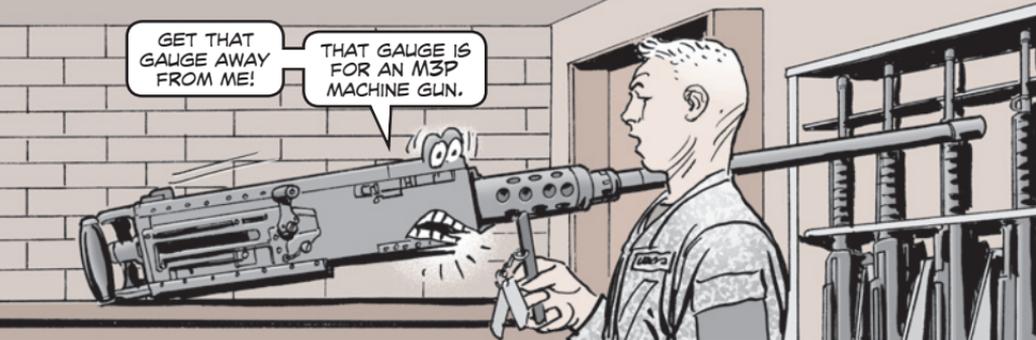
M3P gauge is longer than the M2's

How do you tell the difference? The M2 gauge comes with NSN 5220-00-535-1217 and its headspace gauge is marked both NO FIRE and FIRE. The M3P gauge comes with NSN 5280-13-116-6359 and its headspace gauge is marked NO FIRE, but not FIRE. The M3P headspace gauge is also noticeably longer than the M2's.

But that wasn't it! It was the wrong headspace and timing gauge. The unit had mixed up M2 gauges with those for the M3P, the .50-cal weapon used on the Avenger. The M2 and M3P gauges are different sizes and can't be interchanged.

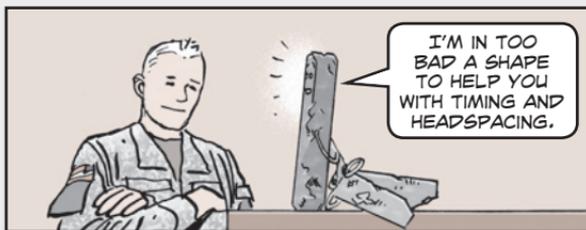
Of course, even if you have the right gauge, it won't do you any good if it's rusted, pitted or bent. If your headspace and timing gauge is in bad shape, tell your armorer you need a new one.

I'M IN TOO BAD A SHAPE TO HELP YOU WITH TIMING AND HEADSPACING.

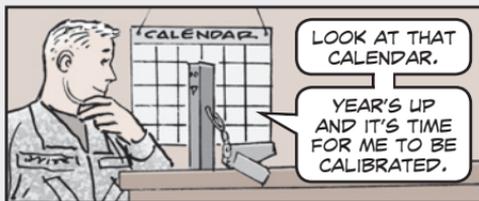
Armorsmen, the gauges must be calibrated every year by your local TMDE if they are to stay accurate. It's your responsibility to make sure that happens and the calibration is documented on a DA FORM 3023 with the gauge's serial number.

LOOK AT THAT CALENDAR.

YEAR'S UP AND IT'S TIME FOR ME TO BE CALIBRATED.
