MISSING WASHER KILLS CRANE

If the crane on your HEMTT wrecker won't work, it could be due to a small star washer that's missing from the ground wire.

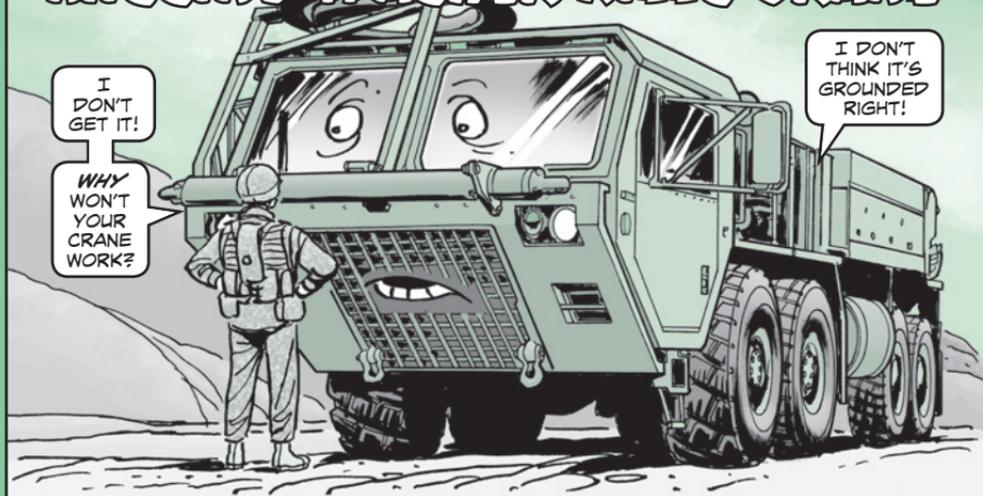
The washer, NSN 5310-00-935-8984, is shown on Page 14-13 of TM 9-2320-279-20-2 for axle No. 4, but it's shown in the wrong place.

THE WASHER SHOULD BE LOCATED BETWEEN THE GROUND WIRE AND THE FRAME, **NOT** BETWEEN THE GROUND WIRE AND THE NUT.

IF IT'S MISSING OR IN THE WRONG PLACE, HAVE YOUR MECHANIC FIX IT LIKE THIS...

1. Take off the nut and ground wire.
2. Scrape a spot of paint, about the size of a quarter, from around the bolt hole.
3. Put on the star washer, followed by the ground wire and then the nut.
4. Torque the nut to 110 lb-ft.
5. Spot paint any remaining bare metal with CARC.

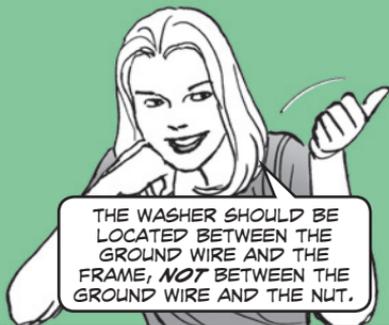
Washer goes between ground wire and frame
