M109-Series SP Howitzer,  
M992A2 Ammo Carrier...

## BAD PACKING: AN EXHAUSTING PROBLEM

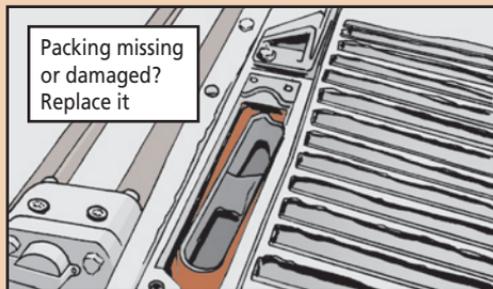
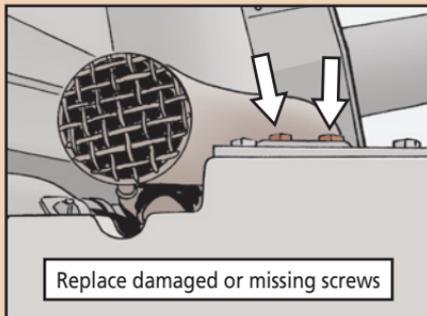
Crewmen, does your howitzer or ammo carrier have exhaust leaks in the engine compartment?

If so, the culprit could be a worn-out exhaust deflector packing. It's supposed to plug up the space between the deflector and the end of the engine exhaust pipe.

Once the packing is worn enough, you'll get exhaust leaks in the engine compartment. That's a dangerous problem.

Replace that packing when you start seeing leaks. A new packing comes with NSN 5330-01-382-4272. Use the whole packing to fill the gap between the deflector and the hull mount.

If the seal support is bent so the deflector won't seat right, replace it. Use NSN 2990-00-894-0075 for a new support.

Make sure the cap screws that hold the deflector snug against the packing are not stripped or cross-threaded. Replace bad screws with NSN 5305-00-269-3238. That NSN brings 100 screws.

And when it's time to pull the powerpack, make sure you take off the exhaust deflector first. Otherwise, the deflector gets ripped off when you remove the deck.
