EXTRACT BAD EXTRACTOR PINS

Some bad M249 machine gun extractor pins have gotten into the Army supply system. They need to be extracted ASAP.

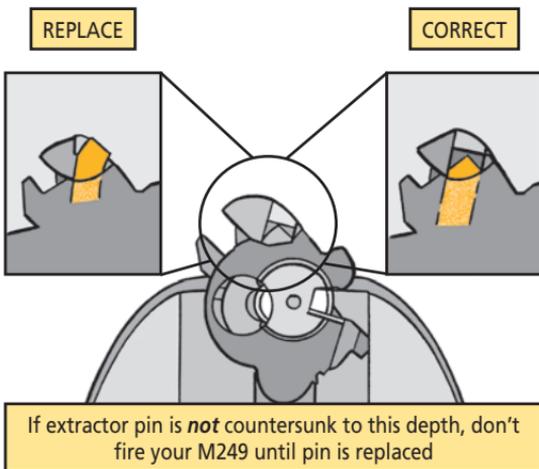
But you don't need to stop firing your M249s until the new extractor pins arrive. What you do need to do is check the extractor pin before firing, during PMCS and maintenance, and every 500-1,000 rounds. The extractor pin should be countersunk to the depth shown here:

Unless your M249s are new or have just come from overhaul at Anniston Depot, their extractor pins, NSN 1005-01-225-8340, should be replaced. All extractor pins in gun extractor parts kit, NSN 1005-01-383-0168, should also be replaced.

If the pin seems to be working out, don't fire the M249 until you get the pin replaced.
