# SHOCK MOUNT BRACKET BOLT JOLT!

**I**f you have an RG-33L, RG-33 SOCOM, RG-33 HAGA, RG-33L Plus or HAGA Plus MRAP here's a shock about the bolts that attach shock mounts to leaf springs!

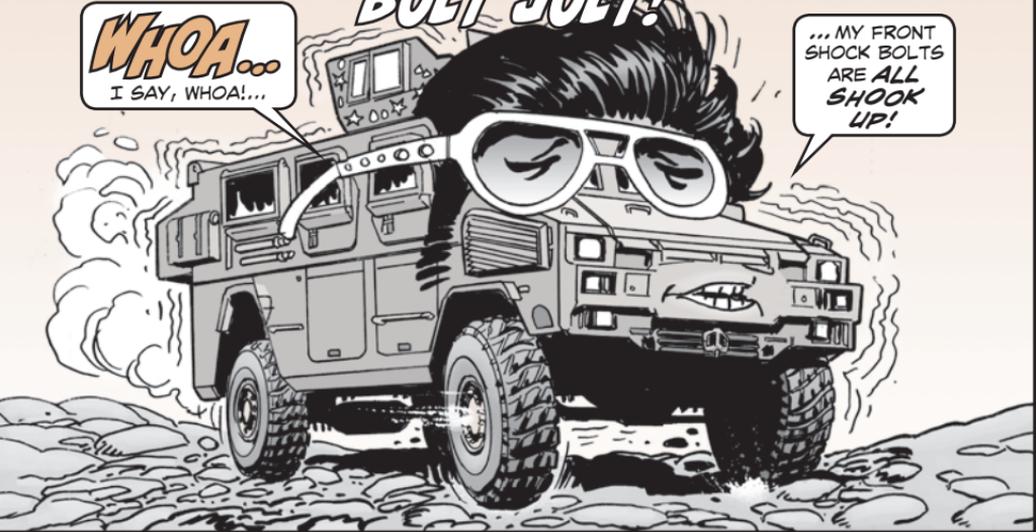
... MY FRONT  
SHOCK BOLTS  
ARE ALL  
**SHOOK  
UP!**

You need to replace all the lower forward shock absorber mount bracket bolts and nuts that have not been marked with a torque marking. If you don't have a torque mark or your torque-marked hardware has become loose, use new nuts and bolts to remount the shock mounts. These nuts and bolts are intended for one time use only.

Torque the new mount bolts to 420 ft-lbs. For RG-33 SOCOM, RG-33L or HAGA variants, use NSN 5306-00-177-5672 to get new bolts. NSN 5306-00-576-2624 gets new bolts for the RG 33L Plus and HAGA Plus variants. The replacement nut for all variants comes with NSN 5310-01-484-7860.

After installing and torquing new bolts and nuts, paint a torque mark strip across each set. This will make it easier to see if nuts and bolts are working loose. It is also a visual cue for seeing which of your vehicles have had their nuts and bolts replaced and torqued properly. If nuts and bolts work loose again, replace them with new nuts and bolts and make another torque mark.
