Old Cadillac Causes New Handstation Problem

A NEW COMMANDER'S HANDSTATION, PN 12976221-21, HAS BEEN FIELDIED FOR THE A3 BRADLEY.

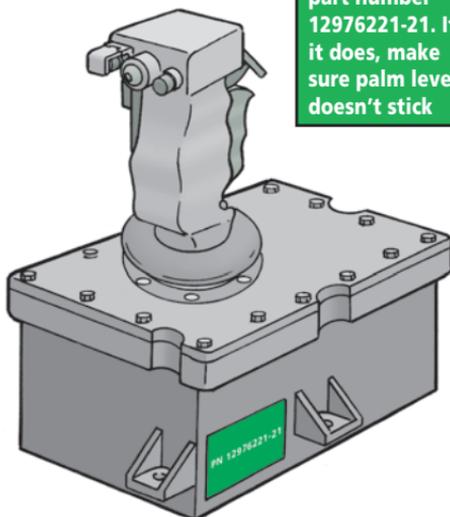
If the palm lever assembly (also known as the Cadillac) of the grip and gimbal assembly of the old handstation is installed in the new handstation, the turret or gun could move unexpectedly. That's a danger to your crew.

Check to see if handstation has part number 12976221-1. If it does, make sure palm lever doesn't stick

If your Bradley has a handstation with PN 12976221-21, make sure the palm lever (Cadillac) doesn't stick when it's depressed. This test can be done with the turret power on or off. But be careful doing it with the power on because the turret or gun could suddenly move. If the palm lever is sticking, get your repairman to replace it with the new lever assembly, PN 12976320-1. Don't use the handstation in the meantime.

There is no safety problem with using the new grip and gimbal assembly, PN 12976231-1, with the old handstation as long as the new lever assembly, PN 12976320-1, is installed.
