BATTERY SPACER PLATE'S FATE

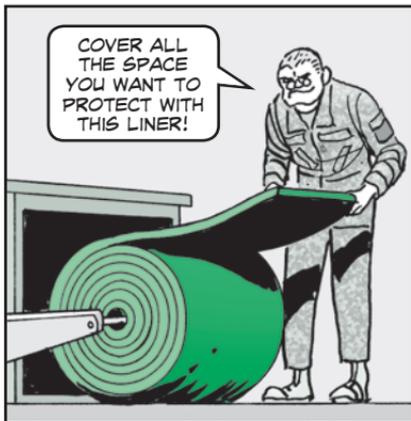
While servicing M920 tractor trucks, I've noticed a recurring problem. The wooden spacer plate, NSN 5365-01-079-6540, that goes under the batteries often rots and needs replacing. That part costs almost \$50.

COVER ALL
THE SPACE
YOU WANT TO
PROTECT WITH
THIS LINER!

Certainly. You still have to use the spacer plate, but here's a tip that should help you out. Use battery box liner, NSN 6160-01-389-1966.

The battery box liner should absorb and neutralize battery acid and prevent corrosion to the box. You'll have to cut enough liner to cover the entire bottom of your truck's battery box.

Then replace it whenever you need to.
