REAR BRAKE CHAMBER BOLT CLEARANCE CUT

WORD FROM THE FIELD IS THAT 5-TON FMTVS HAVE A **BOLT INTERFERENCE PROBLEM.**

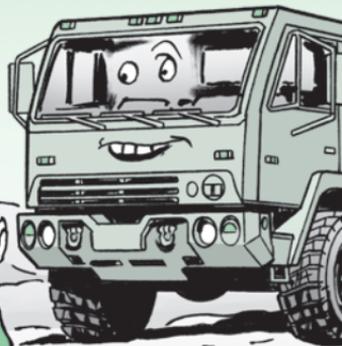
The problem occurs while using the 5 1/4-in caging bolts, NSN 5306-01-500-8736, PN A-4X-1883, on the rear brake chambers. The rear shock absorbers are in the way of putting the bolts in the end of the chambers.

When you encounter this problem, just use the four shorter (3-in) caging bolts, NSN 5306-01-479-1492, PN 12422439. They are stored on the rear axle castings. These bolts were designed to fix this problem, so use them only for caging the rear brake chambers if the longer bolts don't fit. And store the longer caging bolts you won't be using on the holding fixture found on the side of the brake chamber housings.
