# DON'T SHRUG OFF SHROUD

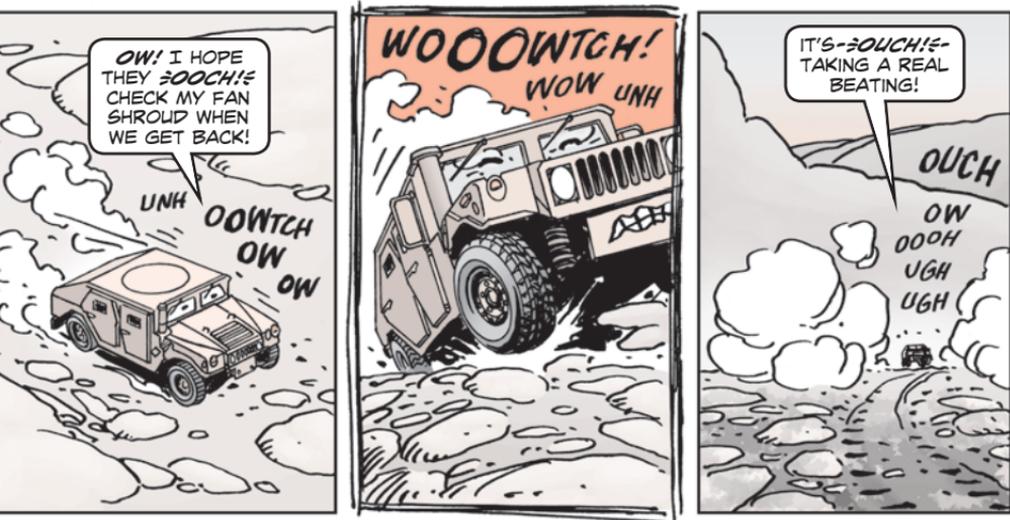
**D**rivers, if you've been doing a lot of cross-country driving lately, the fiberglass fan shroud in your HMMWV may have taken a beating.

The bottom of the shroud gets hit by brush, rocks, tree stumps and road debris. That cracks the shroud and can even bend it inward enough that it gets hit by the fan blades. That means even more shroud cracks and possibly a shattered blade.

So take a look at the bottom of the shroud after you've been operating in the boonies. If you spot problems, tell your mechanic.

He'll repair minor damage with the fiberglass repair kit, NSN 2090-00-372-6064. Cracks and breaks that can be fixed without removing the shroud are considered minor. Major damage means he'll have to replace the shroud following the instructions that start on Page 3-110 of TM 9-2320-280-20-2 (Jan 96 w/Ch 3).
