DOSIMETER BEEN SITTING? IT MAY NEED A BATH!

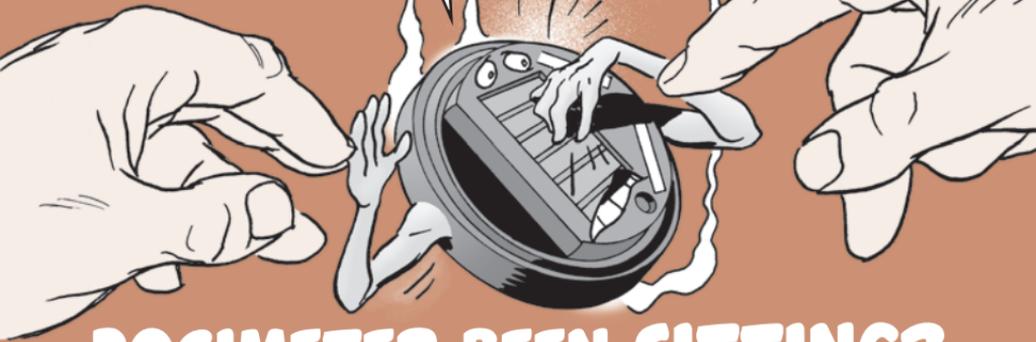
GEE, I'VE
BEEN SITTING
FOR MONTHS!

I REALLY NEED A
BATH IF I'M GOING
TO BE ACCURATE!

If the DT-236 dosimeters, NSN 6665-01-043-2191, for the AN/PDR-75 radiacmeter have been sitting for a long time, they may have lost their accuracy. If that's the case, the dosimeters will give readings on the CP-696/PDR-75 computer indicator that are out of tolerance on the low side.

If your dosimeters have been sitting, they may need a simple cleaning to correct the problem. CBRN specialists, to check if a dosimeter needs cleaning, open it following the procedure in Para 2.6 of TM 11-6665-236-12. With the cover removed, see if the phosphate glass is clear. If the glass is clear, the dosimeter doesn't need cleaning. Put it back together.

But a milky white coating on the surface of the glass means the dosimeter base needs cleaning. Place the dosimeter base in a solution of warm water and liquid dishwashing detergent and let it soak for 5-10 minutes. Rinse the dosimeter base in plain water and let it dry completely. If the glass is now clear, reassemble the dosimeter. If it's not clear, repeat the cleaning process until it is clear.
