MK II and MK III Husky...

STEERING PUMP DAMAGE

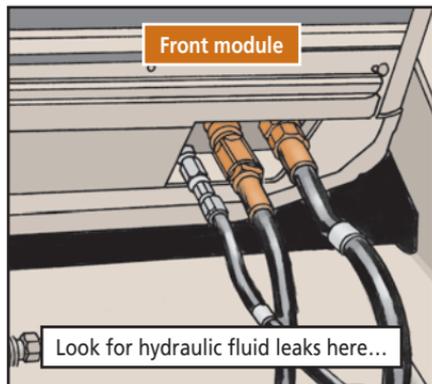
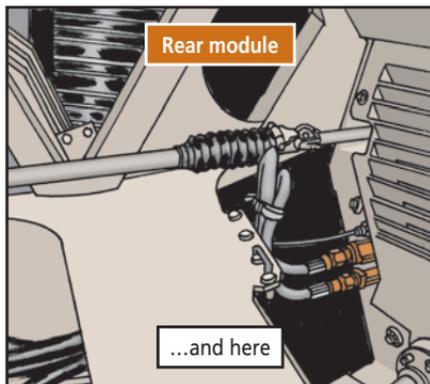
Mechanics, make sure the quick-disconnect couplings are good and tight when you swap out a front or rear module on the MK II or MK III Husky.

A loose connection causes hydraulic oil in the power steering pump to back up. When oil can't flow—and has no place to go—guess what? All that pressure causes the pump to crack and leak. Enough of a leak means no oil, causing the pump to burn out. When that happens, you won't have any power steering—not good!

So, do yourself a favor. Make sure the couplings are good and tight! Also, when the couplings are removed during maintenance, make sure the locking bearings in the female coupling slide back and forth freely. Stuck couplings may be clogged with dirt and sand.

Damaged couplings? Replace the female coupling with NSN 4730-01-554-8869. NSN 4730-01-555-5385 gets the male coupling.
