CLEAN SLIP RING IN SEGMENTS

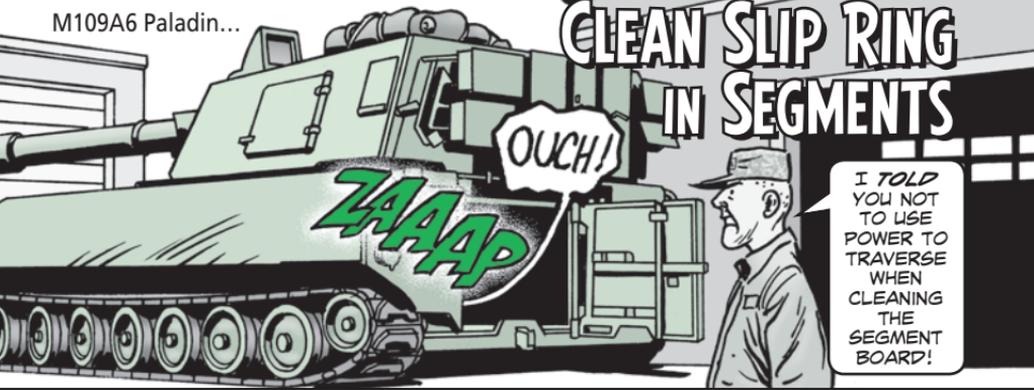
Dirt, sand, oil, and condensation have a habit of collecting on your Paladin's slip ring, crewmen. As the turret is traversed, that crud builds up on the segment board and shorts it out. Things go downhill from there. A shorted segment board shuts down your commo and the vehicle motion sensor. You'll also get navigation faults in the automatic fire control system.

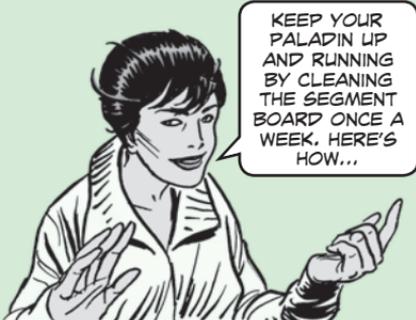
1. Remove the cover plates over the segment board.

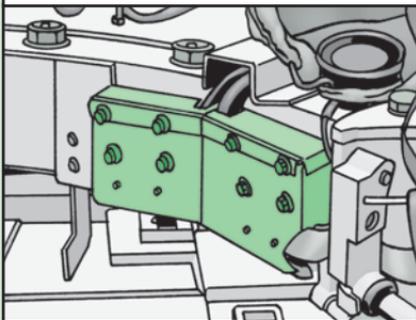
2. Soak a nylon scrub pad, NSN 7920-00-753-5242, with denatured alcohol and clean the exposed portion of the board.

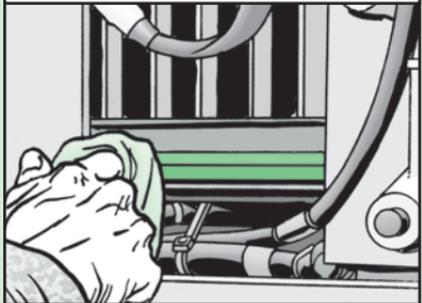
3. Wipe the scrubbed area of the board again with a clean cloth

4. Manually traverse the turret enough to expose the next portion of the segment board and clean again. Keep manually traversing until the entire board is clean. Watch out, though! Using power to traverse the turret will give anyone cleaning the segment board a big *shock!*
