TRANSFER GEAR LOCK NEEDS EXERCISE

NO LUBE FOR ME, PLEASE

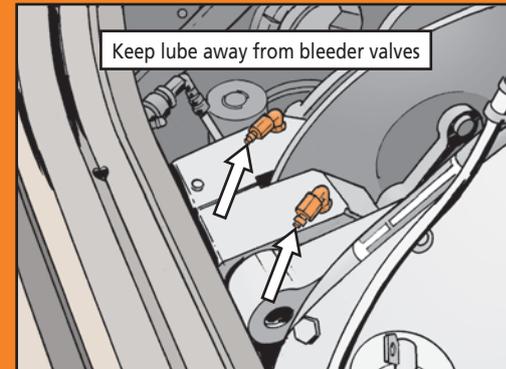
Keep lube away from bleeder valves

The valves may look a lot like grease fittings, but they're not.

Grease clogs the valves and keeps you from bleeding the system. Cleanup is no fun, either. Your mechanic will have to remove the bleeder valves and clean them with solvents and compressed air.

It's easy to prevent this problem, though. Just make sure you keep the grease gun away from those valves the next time you lube.
