Cab Mount Care

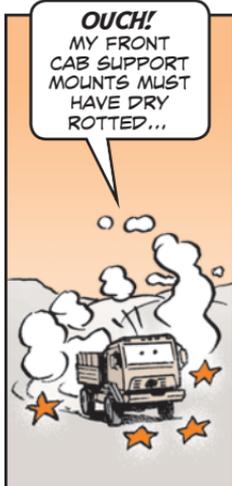
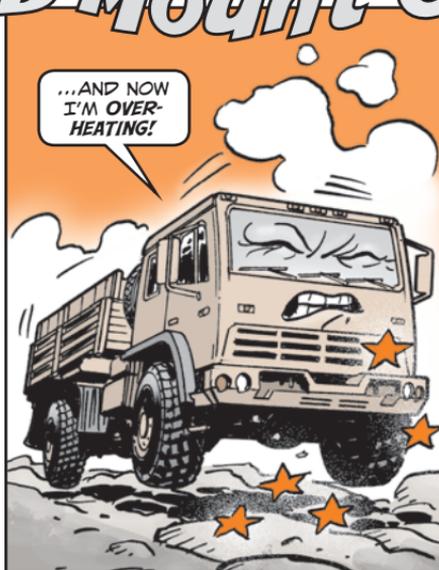
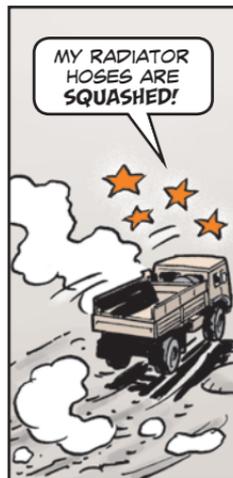
Drivers, when doing weekly PMCS on your -A0 and -A1 model FMTVs, make sure you do a thorough job with the exterior checks. And don't forget to take a look at the front cab support mounts. The upper mount, NSN 5342-01-371-7973, and the lower mount, NSN 5342-01-371-7258, can dry rot over time.

First you'll notice splits in the rubber. Soon after that they'll begin to fall apart.

So if you notice cracks, tell your mechanic. New rubber mounts can save you a lot bigger repair bill later.

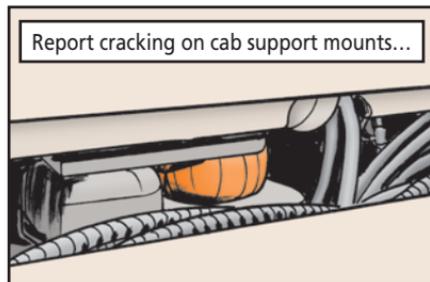
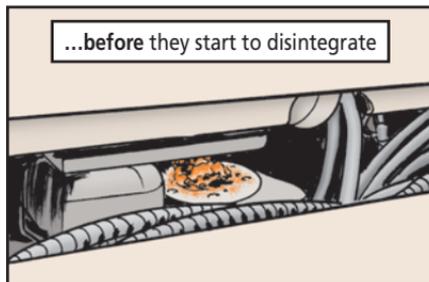
Without the mounts, every bump makes the cab rock and bounce. And when you raise or lower the cab, it can tilt, putting extra stress on the hydraulic struts. For trucks with the weight of add-on armor, those stresses are even worse.

Broken cab mounts can also lead to squashed radiator hoses that can lead to overheating.
