FILTER A HAZARD TO HANDS AND EYES

Mechanics, when replacing the M48A1 gas particulate filter unit, NSN 4240-01-363-1311, on an M1-series tank, be **very** careful as you open the filter's container.

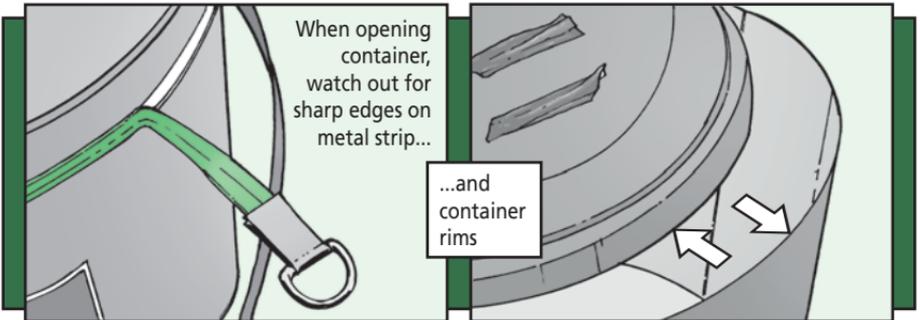
The container is opened by pulling on a key tab that removes a metal strip around the container. Both the metal strip and the edges left on the container are very sharp and quite capable of giving you a nasty cut. So make sure you're wearing cut-resistant gloves when opening the container.

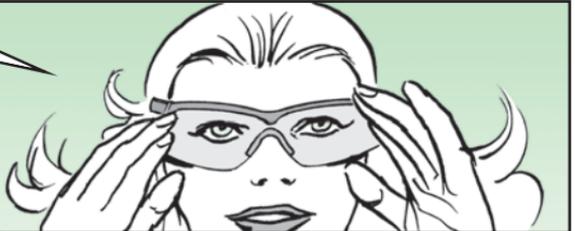
EYE PROTECTION IS A **MUST**, TOO.

WHEN THAT METAL STRIP PULLS LOOSE FROM THE CONTAINER, THE TENSION CAN MAKE IT **SNAP BACK**, PUTTING YOUR EYES AT RISK!
