## INSPECT YOUR AIRCRAFT

**P**ilots, now that the Kiowa Warrior has the new M3P .50 cal machine gun, NSN 1005-01-303-5250, strapped to its pylon, things just got a little more interesting.

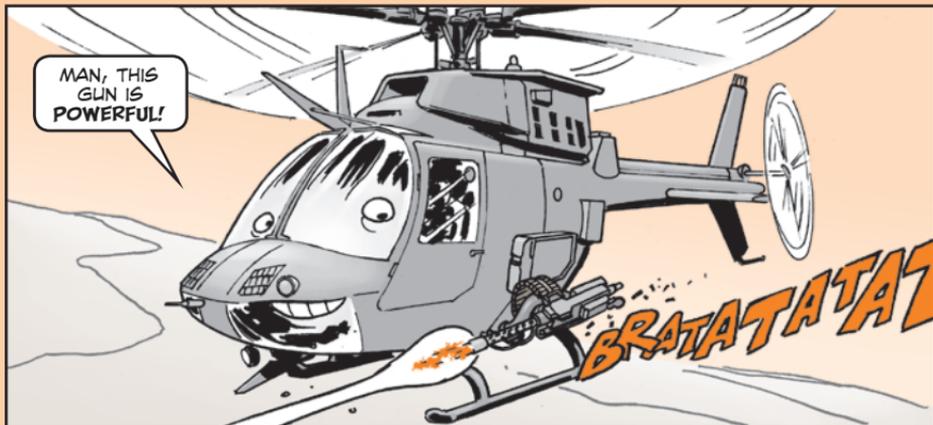
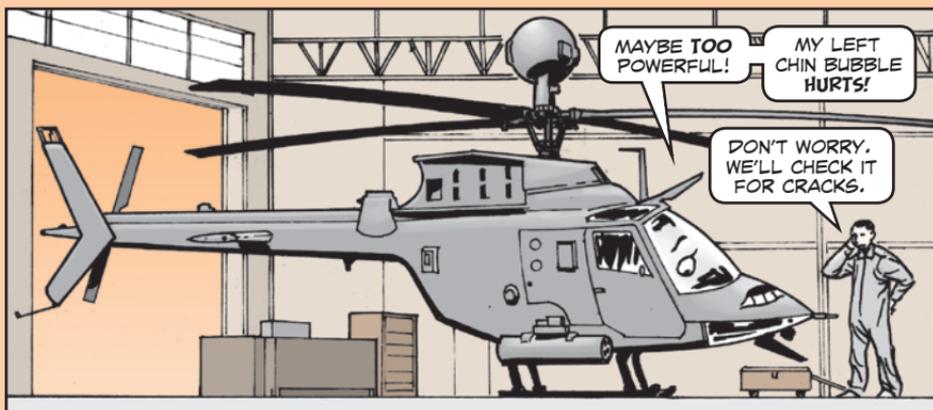
After each firing of the gun, check your aircraft chin bubble and the area around the static port for damage.

Unlike the old M296 .50 cal machine gun with its shorter barrel, the M3P gun's longer barrel, plus vibration and rapid firing, can cause cracks in the chin bubble. Any time the gun is fired, it sends out powerful shock waves. The chin bubble on the pilot's side of the aircraft takes the brunt of the rapid firing of 1,100 rounds per minute.

If you find cracks in the chin bubble, call your airframe shop to fix the cracks or replace the chin bubble. They may also need to repair the aircraft skin if there's damage.
