WHILE YOU'RE AT IT, ALSO CHECK THE FIRING PIN ASSEMBLY FOR THESE PROBLEMS...

## COEI Stays with M119A2

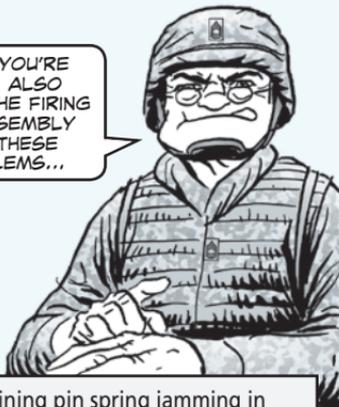
- retaining pin spring jamming in the housing on the lock assembly
- retaining pin knob not turning or turning with difficulty

Retaining pin knob hard to turn?

If the firing pin is defective, turn it in to Contractor Logistics Support for free replacement.
