Up-Armored
HMMWV...

FIX CARGO SHELL LATCH PLATE FAILURE

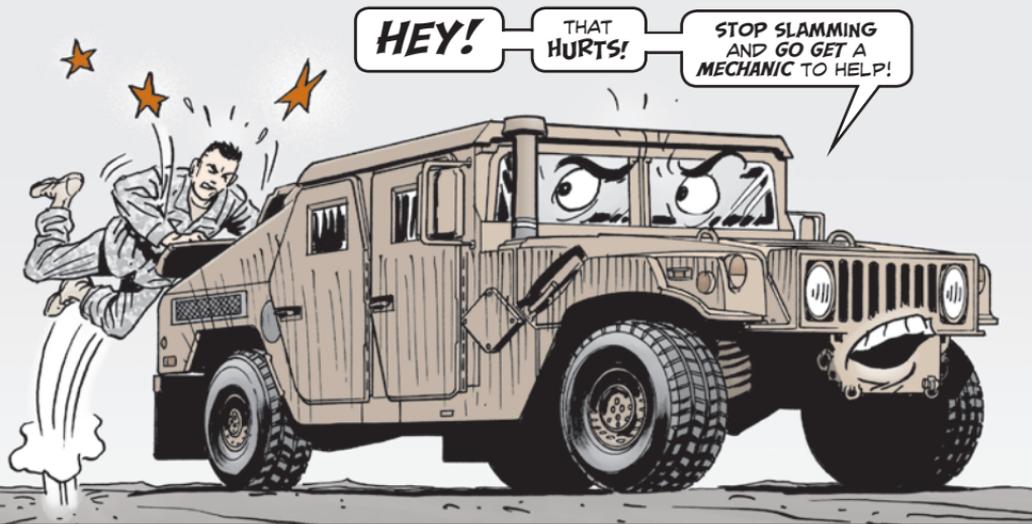
If your M1151, M1151A1, M1151A1WB1, and M1167 HMMWVs have failing cargo shell forward latch plate assemblies, you might be a little frustrated. Here's what you can do to prevent the failures and ease the frustration.

But if you do all that and there's still a problem, your HMMWV's cargo shell forward latch plate assembly may have failed.

If your HMMWV's hatch doesn't close smoothly during PMCS, tell your mechanic. And make sure you're opening and closing it the right way.

Also, ensure the forward latches are fully engaged with the forward strikers before opening the cargo door from the rear position. That should help protect the cargo shell forward latch plate assembly.

You can't find replacement procedures in the TM yet, but you can get them from TACOM LCMC. Just send your unit information and request to:
