**COVER
ME UP
WHEN IT'S
WASH
TIME!**

EASY FIX FOR RIFLE BRACKET INTERFERENCE

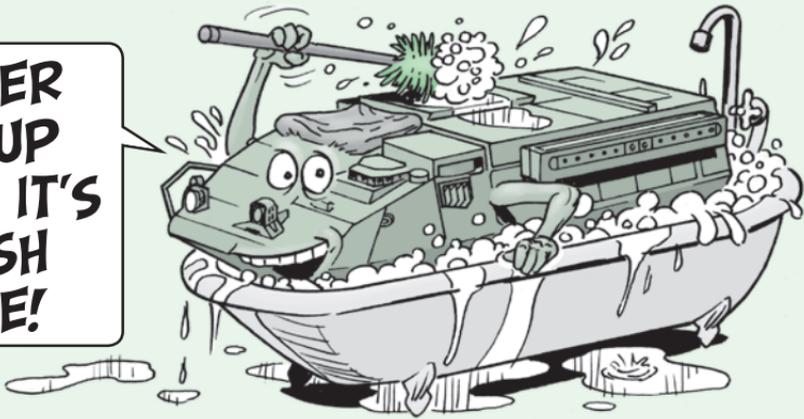
Washing your Stryker without first installing the environmental cover could lead to some big problems. Not using the cover means water can get into the engine air intake and exhaust, which could blow the pack.

Don't wash Stryker without environmental cover in place

So before you grab the hose, be sure to grab the environmental cover first and secure it in place. Also, don't forget to install the heater exhaust cover, NSN 2590-20-000-0256. It's part of your Stryker's components of end item (COEI).

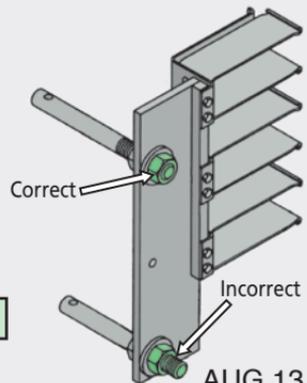
MWO 9-2350-314-30-5 replaced the shafts for those brackets. But some of the shaft nuts were screwed down too far. The nut should be flush with the shaft to prevent interference with the Excalibur rounds on their racks.

Ensure ends of shafts are flush with face of nuts

Check the shafts now. If you find any that aren't flush with the nut, adjust the nut until they are.
