# THE HEART-BREAK OF MOUNT SLAMMING

The AN/PSN-13 and -13A defense advanced GPS receivers (DAGR) are ruggedized—but they're not unbreakable.

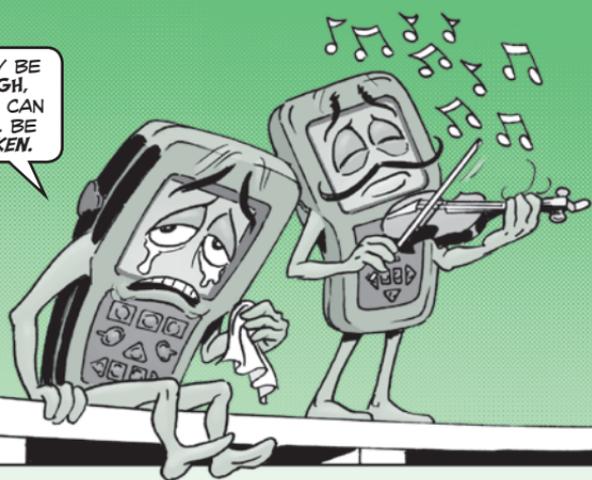
The damage is to DAGRs used in vehicle mounts. What causes it? **“Mount slamming.”** That's when you secure the upper part of the DAGR behind the mount's spring-loaded pins, also known as plungers. Then you slam the DAGR up and over the lower mounting tabs. This manhandling gouges the DAGR's shell and sends blunt force trauma to the internal circuit card. The card flexes and cracks. Solder joints and components break.

'Mount Slamming' damages circuit card

1. Pull out and lock the mount's two spring-loaded pins.
2. Insert the DAGR into the lower mounting tabs on the bottom of the mount.
3. Release the spring-loaded pins to grasp the DAGR.

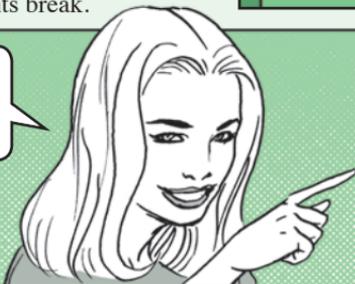
HERE'S THE RIGHT WAY TO PUT THE DAGR IN THE MOUNT...
