Replace M19 Filter *ONLY*

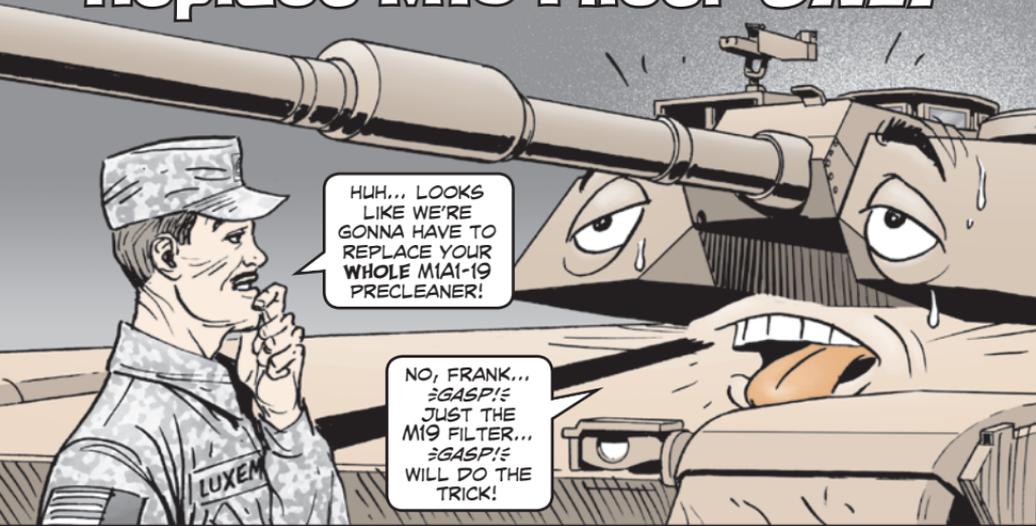
When the M1A1 tank's M1A1-19 precleaner stops working due to lack of air flow, some units replace the entire precleaner. This isn't necessary unless the precleaner is damaged.

Most of the time the problem is that the M19 particulate filter, NSN 4240-00-866-1825, is dirty. In that case, just replace the M19 filter.

The procedures for maintaining and replacing the M19 filter are in TM 3-4240-276-30&P (Dec 97).

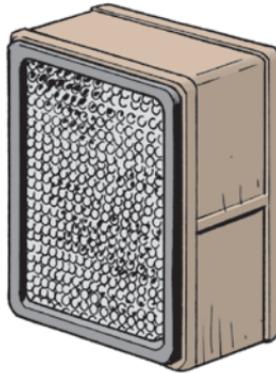
Usually only M19 filter needs replacing
