SECURE HYDRAULIC LINES

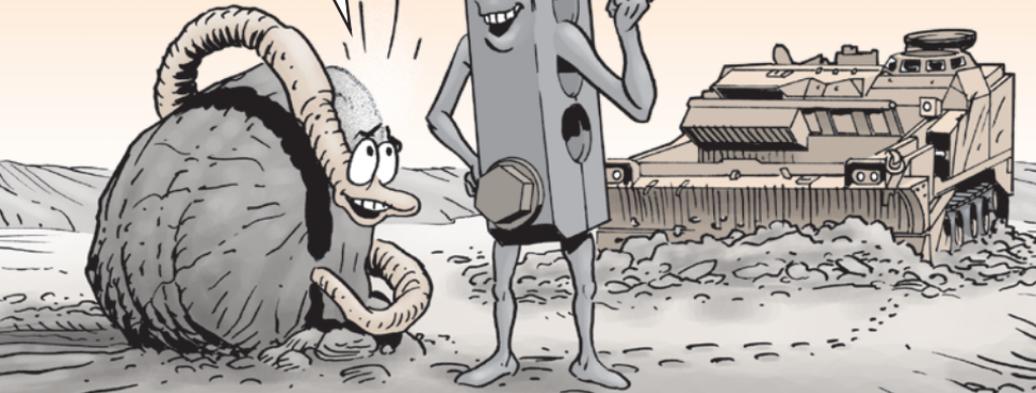
Who would imagine that the lack of a small strap clamp could stop a 27-ton earthmover dead in its tracks?

But it has happened. And that's why you mechanics need to remember the clamp when servicing the five hydraulic lines mounted directly across from the engine's exhaust manifold.

The clamp is needed to keep the hydraulic lines from touching the ACE's hydraulic manifold. If a line touches the manifold when it gets hot, the line could melt and start a fire!

The clamp gets misplaced when a hydraulic line is replaced or the engine is pulled. If the clamp's missing, replace it with NSN 5340-01-179-7530. You'll find it listed as Item 40 in Fig 156 of TM 5-2350-262-24P (Jun 12).

Until the new clamp comes in, secure the lines away from the manifold with a tie-down strap, NSN 5975-00-570-9598.
