CONNECTORS NEED A GENTLE TOUCH

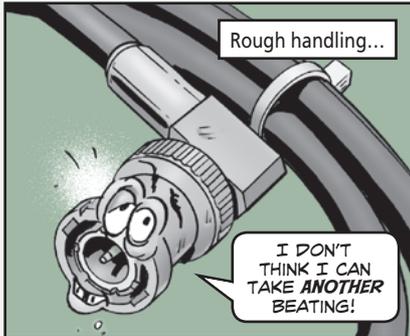
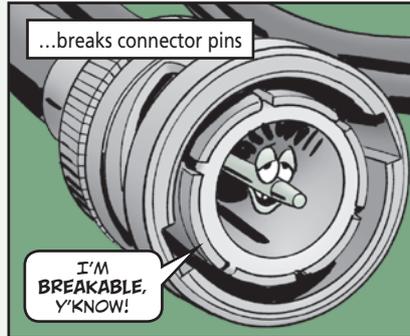
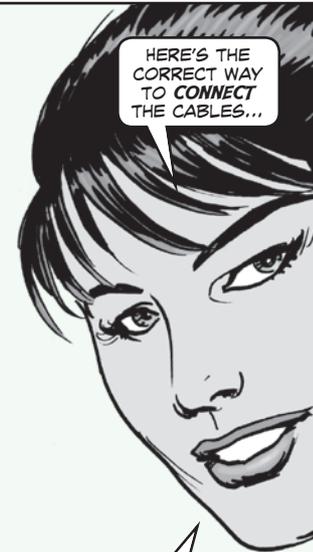
1. Line up the keyhole on the cable connector with the key on the RT's antenna connector or the power amplifier's J1 or J2 connector.

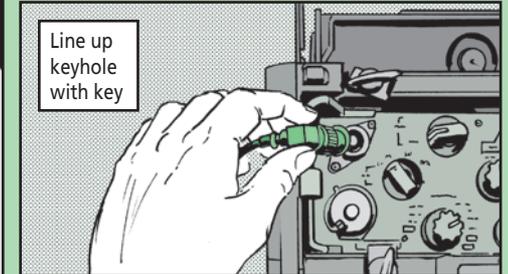
2. Push the cable connector straight in.
3. Turn the cable connector clockwise until it doesn't move any farther.

1. Turn the cable connector counter-clockwise until the keyhole on the cable connector lines up with the key.
2. Pull the cable connector straight out and off.
