MGS Stryker...

BOOT BATTERY TERMINALS FOR SAFETY!

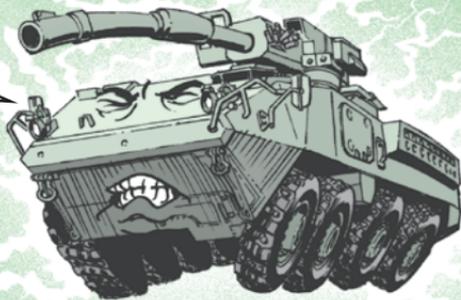
Crewmen, the rubber boots that cover the positive and negative terminals on your mobile gun system (MGS) Stryker's auxiliary battery box play an important role. If they're missing or damaged, an electrical short could happen. That short can cause a vehicle fire!

The rubber boots can get damaged or slide down the battery cables, exposing the terminals.

Battery terminal boots and battery box cover should be in place and undamaged

Investigators believe missing or improperly installed battery terminal boots caused a recent fire that destroyed an MGS Stryker.

During AFTER and WEEKLY PMCS, make sure the boots are installed correctly and are in good condition. If you find any that are missing or damaged, your vehicle is NMC until they're replaced. The negative terminal boot comes with NSN 5975-01-432-5846. Get the positive terminal boot with 5930-01-590-9078. Also, the battery box cover should be in place and fastened tight.

Don't forget to inspect the auxiliary batteries for cleanliness and signs of arcing such as burned areas or melted spots on the rubber covers or metal parts. If you find problems, report them.
