Double V-Hull
Strykers...

Drain Away ABS Troubles

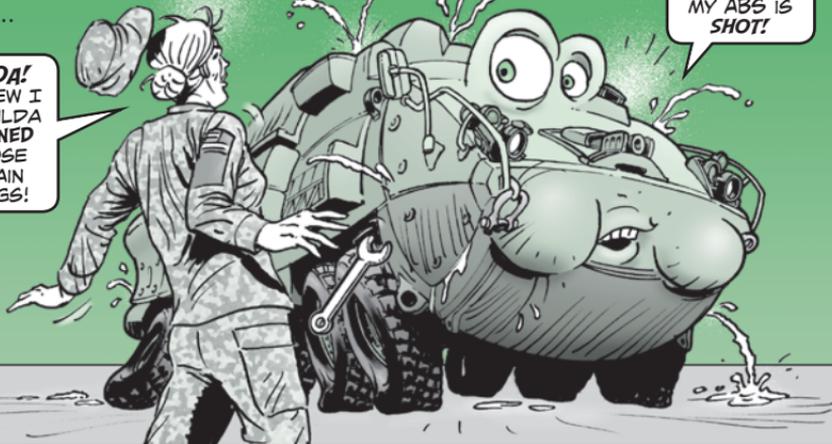
YEAH! NOW
MY ABS IS
SHOT!

WHOA!
I KNEW I
SHOULD'A
OPENED
THOSE
DRAIN
PLUGS!

That's why it's important to protect the ECU from water damage. Just make sure you follow the AFTER PMCS checks and remove the hull drain plugs when washing your vehicle and whenever it's being transported by ship. That'll keep the hull dry and your Stryker's brakes on the job.

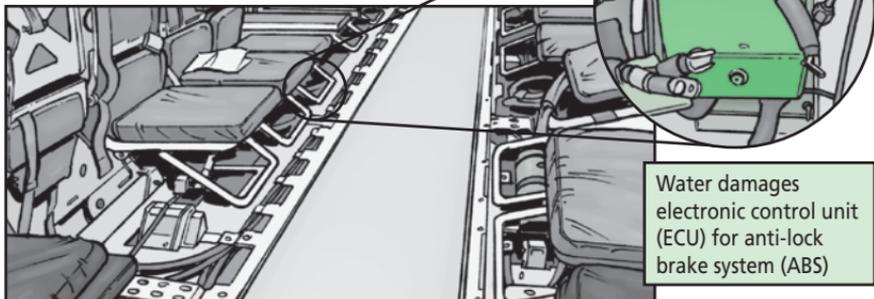
Crewmen, water collecting in the bottom of your double V-hull Stryker can be a problem. But if the water gets high enough to short out the electronic control unit (ECU) for the anti-lock brake system (ABS), the problem becomes a lot more serious.

A faulty ABS can lock up your vehicle's brakes during an emergency stop. That puts you and your fellow crewmembers in danger. It's also why your double V-hull Stryker is NMC if the ABS warning light comes on.
