**PS****THE  
PREVENTIVE  
MAINTENANCE  
MONTHLY**

**ISSUE 705 AUGUST 2011**

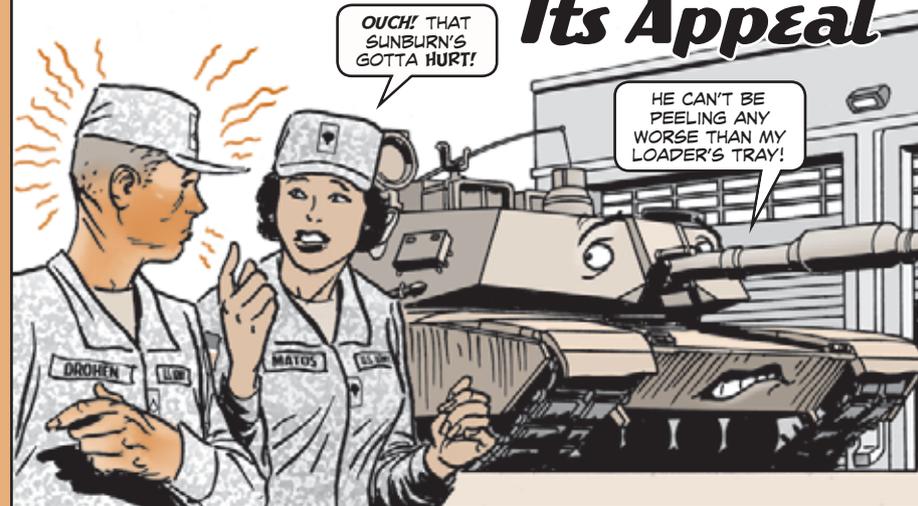
If your loader's tray is peeling, you've probably got a "3rd generation" tray, NSN 1015-01-537-0697 (PN 13010524). Those trays had a Teflon® coating added for extra protection, but they haven't lived up to expectations.

So if your tray is peeling, stop using it now! The peeled coating can get lodged in the chamber or breech and cause problems with firing the main gun.

Get the tray replaced with a new "4th generation" tray, NSN 1015-01-590-9661 (PN 13010524-1). The Teflon® coating on these trays has been replaced with a dry film lube phosphate coating that won't peel.

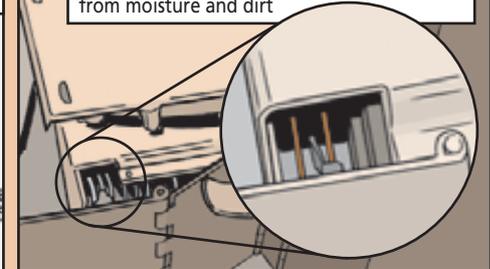
With latches secured, CPU is better protected from moisture and dirt

It's hard to find a single wire tie that's long enough, so you may need to piece two or three together to do the job.

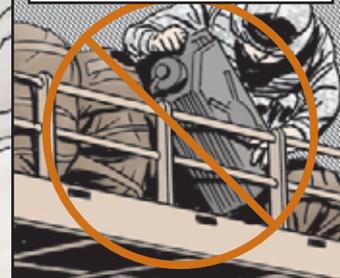
BUT ONE THING YOU DEFINITELY NEED TO KEEP OUT OF IT IS ANY CONTAINER HOLDING FLAMMABLE LIQUIDS.

ONE TANK CREW RECENTLY USED THE BUSTLE RACK TO STORE FLAMMABLE LIQUID AND LEARNED A HARD LESSON.

A LEAK IN THE CONTAINER LET LIQUID DRIP THROUGH THE ENGINE COMPARTMENT ACCESS GRILLE.

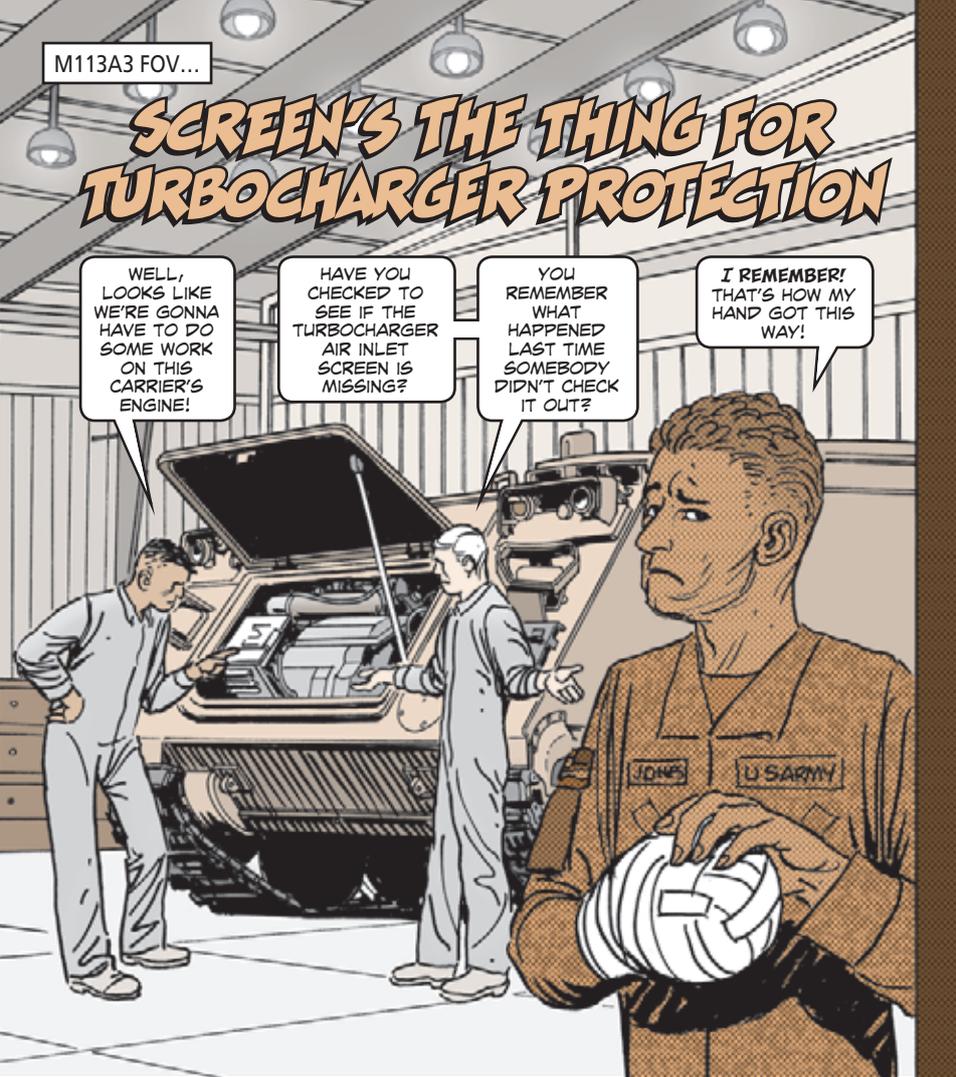
**M**echanics, when working around the M113A3 FOV's 6V53T engine, make **very** sure the turbocharger guard screen and seal are mounted on the air intake horn.

Without the screen, just about anything can be sucked into the turbocharger's impeller. The turbocharger is damaged by any debris that gets sucked inside. Even more importantly, you'll be in a world of hurt if your fingers and hands get too close to the intake.

If the screen is missing, order a new one with NSN 2815-01-281-4930. That NSN also brings the seal. You'll find them listed as Item 24 in Fig 39 of TM 9-2815-205-34P (Oct 05).

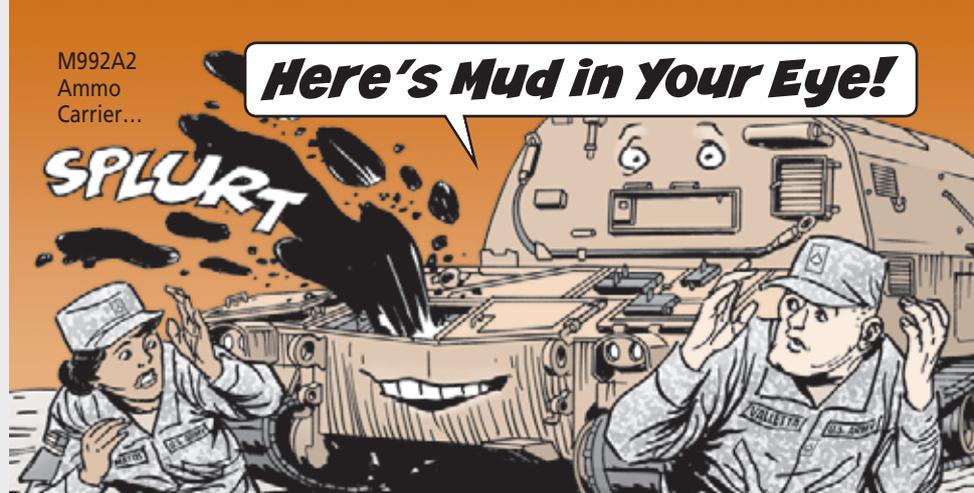
# Here's Mud in Your Eye!

**W**hen you've finished lubing the final drive U-joints, your job's not over. At least not until you wipe away the excess grease.

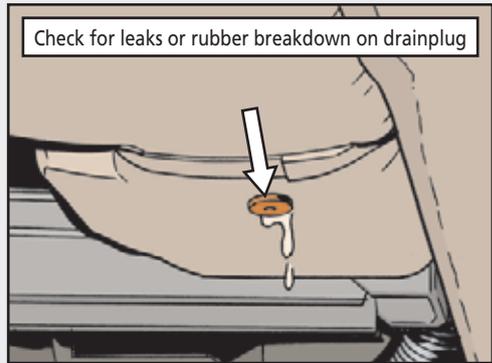
The drainplug consists of a metal screw surrounded by a rubber gasket. If the drainplug is over-tightened, the sharp edge of the hole may cut the rubber. Even if the drainplug's properly seated, the rubber will eventually deteriorate. Either way, you've got a fuel leak.

Drainplug is a metal screw surrounded by rubber

Check the plug before operations as part of your PMCS. A leak should be reported immediately. But even if there's no leak, you should search for signs of deterioration. If the rubber has hardened or is overly soft and smoochy to the touch, report it.

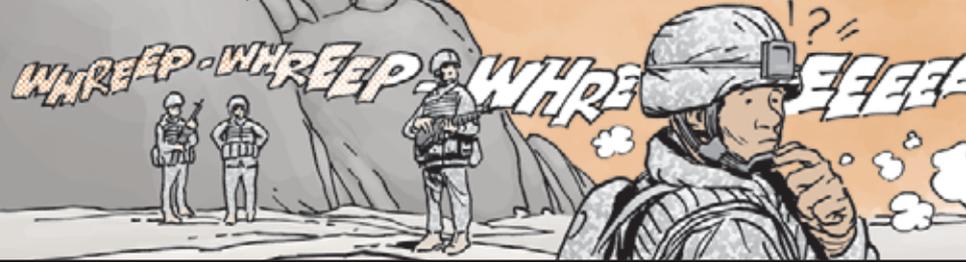
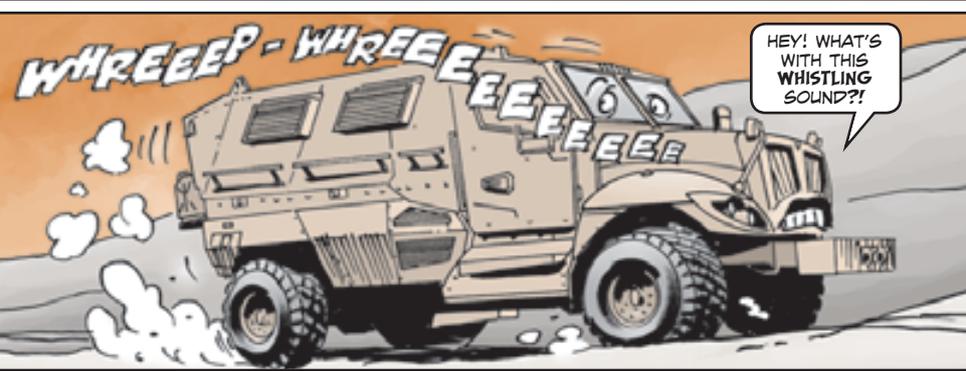
The MaxxPro's hood spring is known to rub against the engine's air intake cooler when the hood is being opened and closed.

Enough rubbing creates a hole in the cooler. That causes an air leak and a loss of intake pressure. Then the engine doesn't get enough cool air to keep it running smoothly—especially in hot weather.

Want to stop the rub? Cut a piece of 1-in tubing, NSN 4720-01-422-0242, and wrap it around the hood spring. You can use duct or electrical tape to hold the tubing in place.

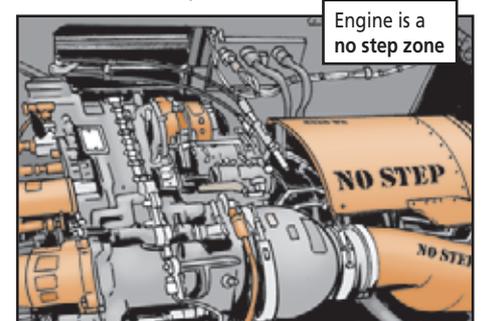
Always use a work stand, a work platform or aircraft step areas for your feet. That way, you avoid breaking the engine's temperature bulb, alternator connector, starter speed sensor wiring, bleed air tube and the hydromechanical unit (HMU). If you step on the HMU, you can break the shaft that goes into the accessory gearbox, including the spline. When your feet contact the engine, that puts the fuel line at risk, too.

You may not notice that damage has occurred, but the internal connections and wiring to the starter speed sensor will let you know. For example, the starter will not sense the engine speed and won't shut off after the engine reaches optimum speed. So the pilot has to shut off the starter manually.

Engine is a no step zone

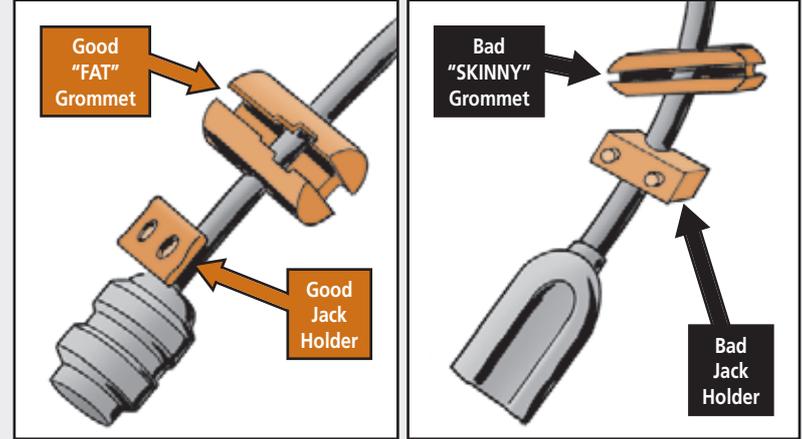
We forgot to tell you that there was a new problem with the communication cord that developed after the first lot. In 2008, DLA stopped purchasing the communication cords directly from Gentex and began to purchase cords directly from several aftermarket manufacturers whose CAGE codes are: 38LK9, 305Q5, and 7Z016. Units started submitting PQDRs against the aftermarket manufacturers in May of 2010. The problems with these aftermarket communications cords involve problems with loose and sloppy over-braiding, cold solder joints, and the failure to use parts called out on the drawing that can be seen in the picture below.

DLA was able to freeze internal stocks of these aftermarket communications cords so no more bad ones would hit the field. Future procurement will be from Gentex.

If your readers have any bad cords marked with cage code 38LK9, 305Q5, and 7Z016 in their ALSE shop, they should not send them back to Gentex. To get credit for any bad cords, they must submit a PQDR like it says in AR 702-7-1, *Reporting of Product Quality Deficiencies Within the U.S. Army*.

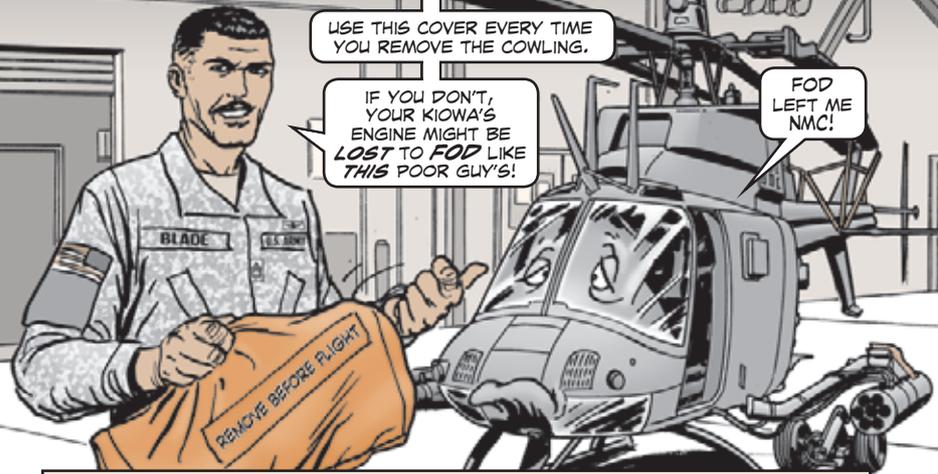
When we perform maintenance on our Kiowa Warrior, the air induction cowling gets removed for access to the engine.

The cowling has open crevices and other places where nuts, bolts, and screws could fall in and become lodged in the cowling. When the cowling is reinstalled and the aircraft is started, those small parts work loose and are sucked into the engine. That always spells disaster!

Something as small as a tiny washer can cause a perfectly good engine to be lost to FOD.

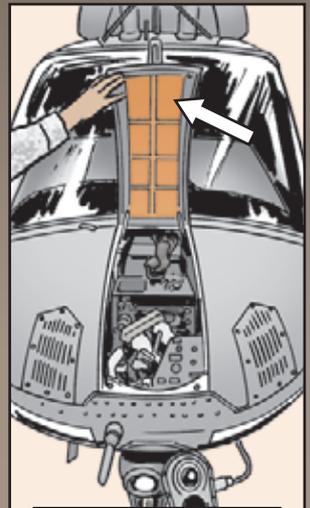
Forcing the door back too far means you'll be telling the airframe repairer the bad news about the extra work you just created. And that means unnecessary aircraft downtime for repairs.

Do not force door too far!

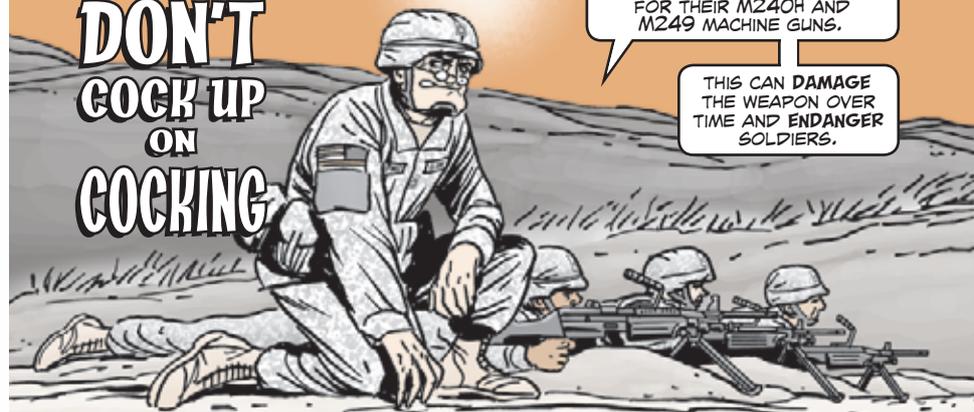
# DON'T COCK UP ON COCKING

SOLDIERS ARE ROUTINELY  
**NOT** FOLLOWING THE LOADING  
AND CLEARING PROCEDURES  
FOR THEIR M240H AND  
M249 MACHINE GUNS.

THIS CAN **DAMAGE**  
THE WEAPON OVER  
TIME AND **ENDANGER**  
SOLDIERS.

If the gunner puts the weapon on SAFE with the bolt forward and then tries to charge the gun, he jams and/or damages it.

Pulling the bolt halfway back and then putting the selector in SAFE causes the sear to rise, blocking the bolt from moving forward. If the gunner then tries to charge the weapon, he damages the sear, plus he can cause the machine gun to jam.

The cocking handle also needs to be locked fully forward after you lock back the bolt. The handle should click into place if it's fully forward. If the handle is not locked forward, it will bang against the cocking handle stop during firing. That wears out the receiver rails and the handle. There is no fix for worn out rails. The weapon must be replaced.

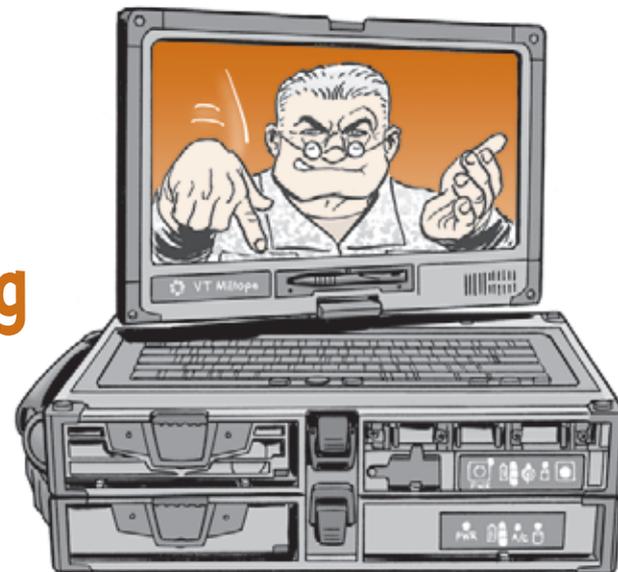
# New MSD Hitting the Field

THE ARMY WILL BEGIN FIELDING THE NEW MSD (MAINTENANCE SUPPORT DEVICE) V3 IN SEPTEMBER, 2011.

THE MSD V3 IS THE FIFTH GENERATION OF THE ARMY'S DESIGNATED AT-PLATFORM, MULTIPURPOSE AUTOMATIC TEST SYSTEM.

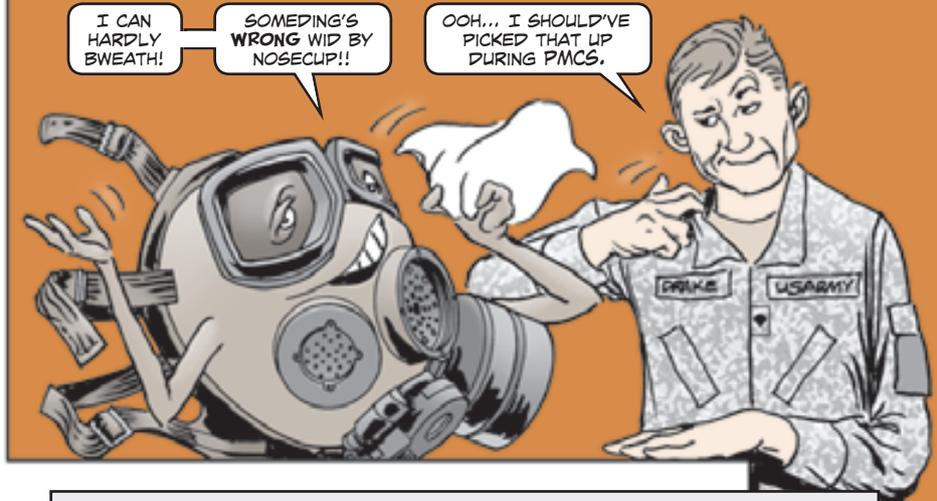
# BEWARE OF LOOSE NOSECUP

In my work with the MAIT at Camp Casey, Korea, I often run into M40/M42 masks in which the nosecup has pulled away from the back of the front voicemitter housing.

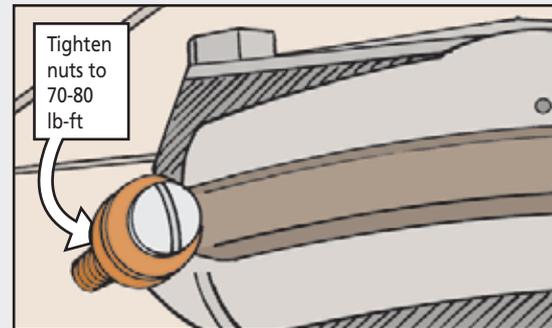
OPERATORS, VIBRATION LOOSENS THE NUTS AND BOLTS THAT HOLD TOGETHER THE BRAKE ACTUATOR AIR CHAMBER CLAMP.

So grab the clamp to see if it's loose. If it is, get your mechanic to re-torque the nuts to 70-80 lb-ft.

Between scheduled 250-hr services, look for loose nuts, shiny spots or rust around the bolt heads and nuts on both the front and rear air brake chambers. If you spot any, tell your mechanic.
